FRONT WHEEL/SUSPENSION/STEERING

BUSHING/BACK-UP RING

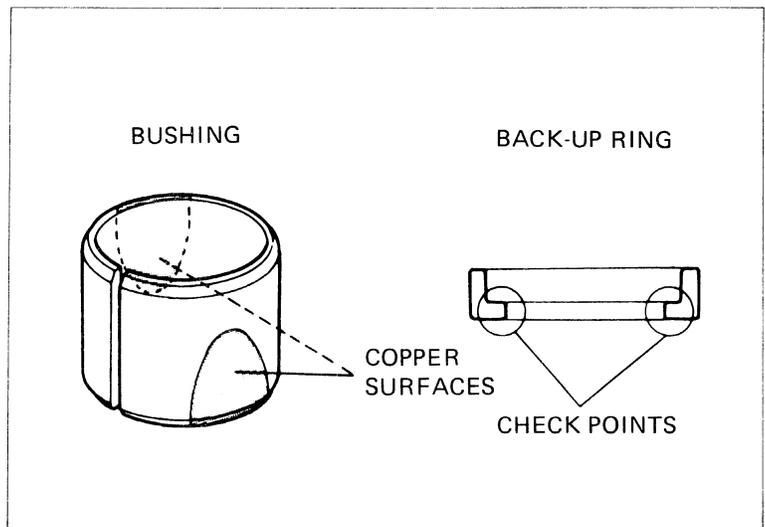
Visually inspect the slider and fork tube bushing. Replace the bushing if there is excessive scoring or scratching, or if the teflon is worn so that the copper surface appears on more than 3/4 of the entire surface.

Check the back-up ring at the points shown. Replace if there is any distortion at the points shown.

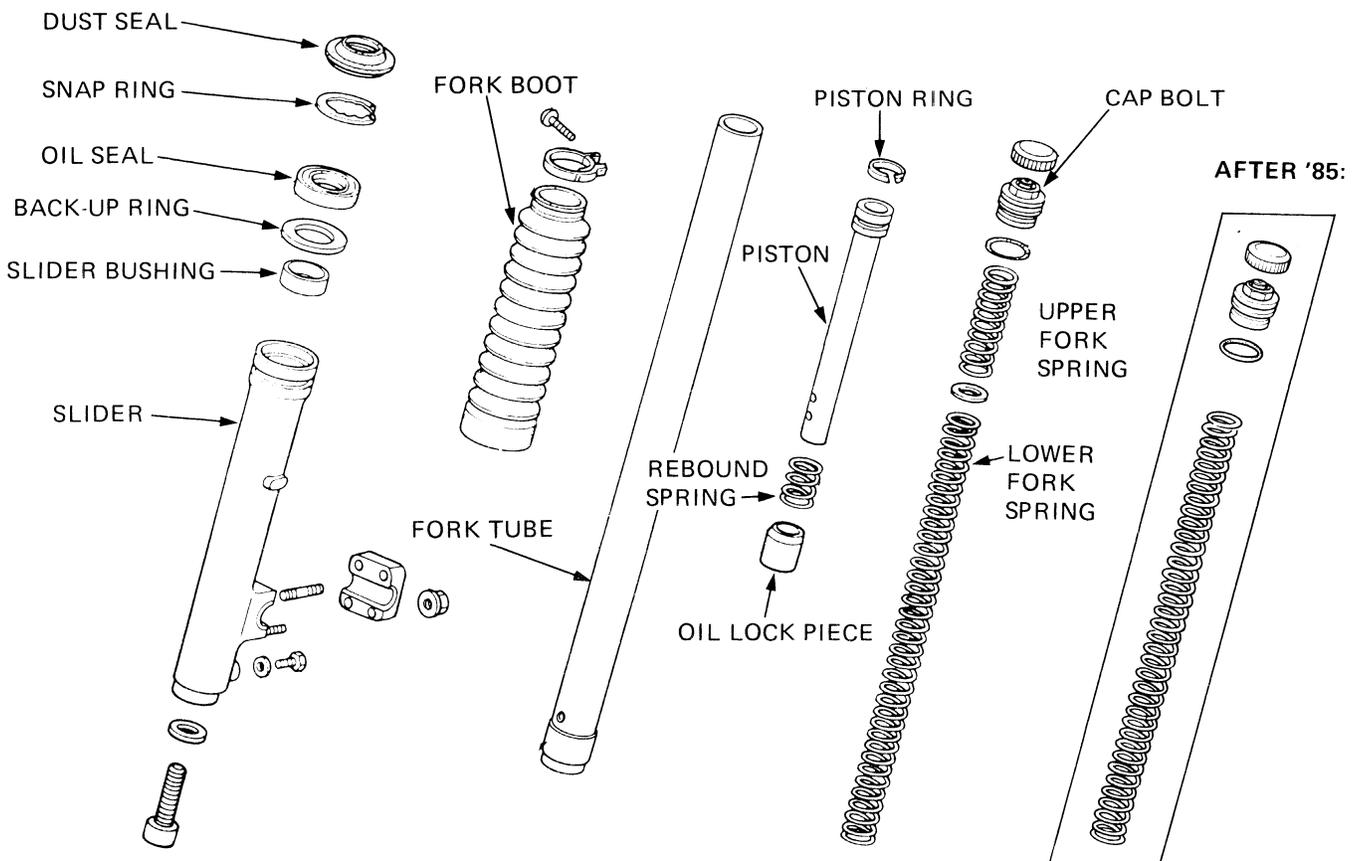
ASSEMBLY

Wash all removed parts in solvent and wipe them off thoroughly before assembly.
